Inspector's Daily Report

IDR Sheet	1	of	1	Sheets	Final Record Book	Page
Contract	C-7852			Day	Wednesday	
				Date	September 29, 2010

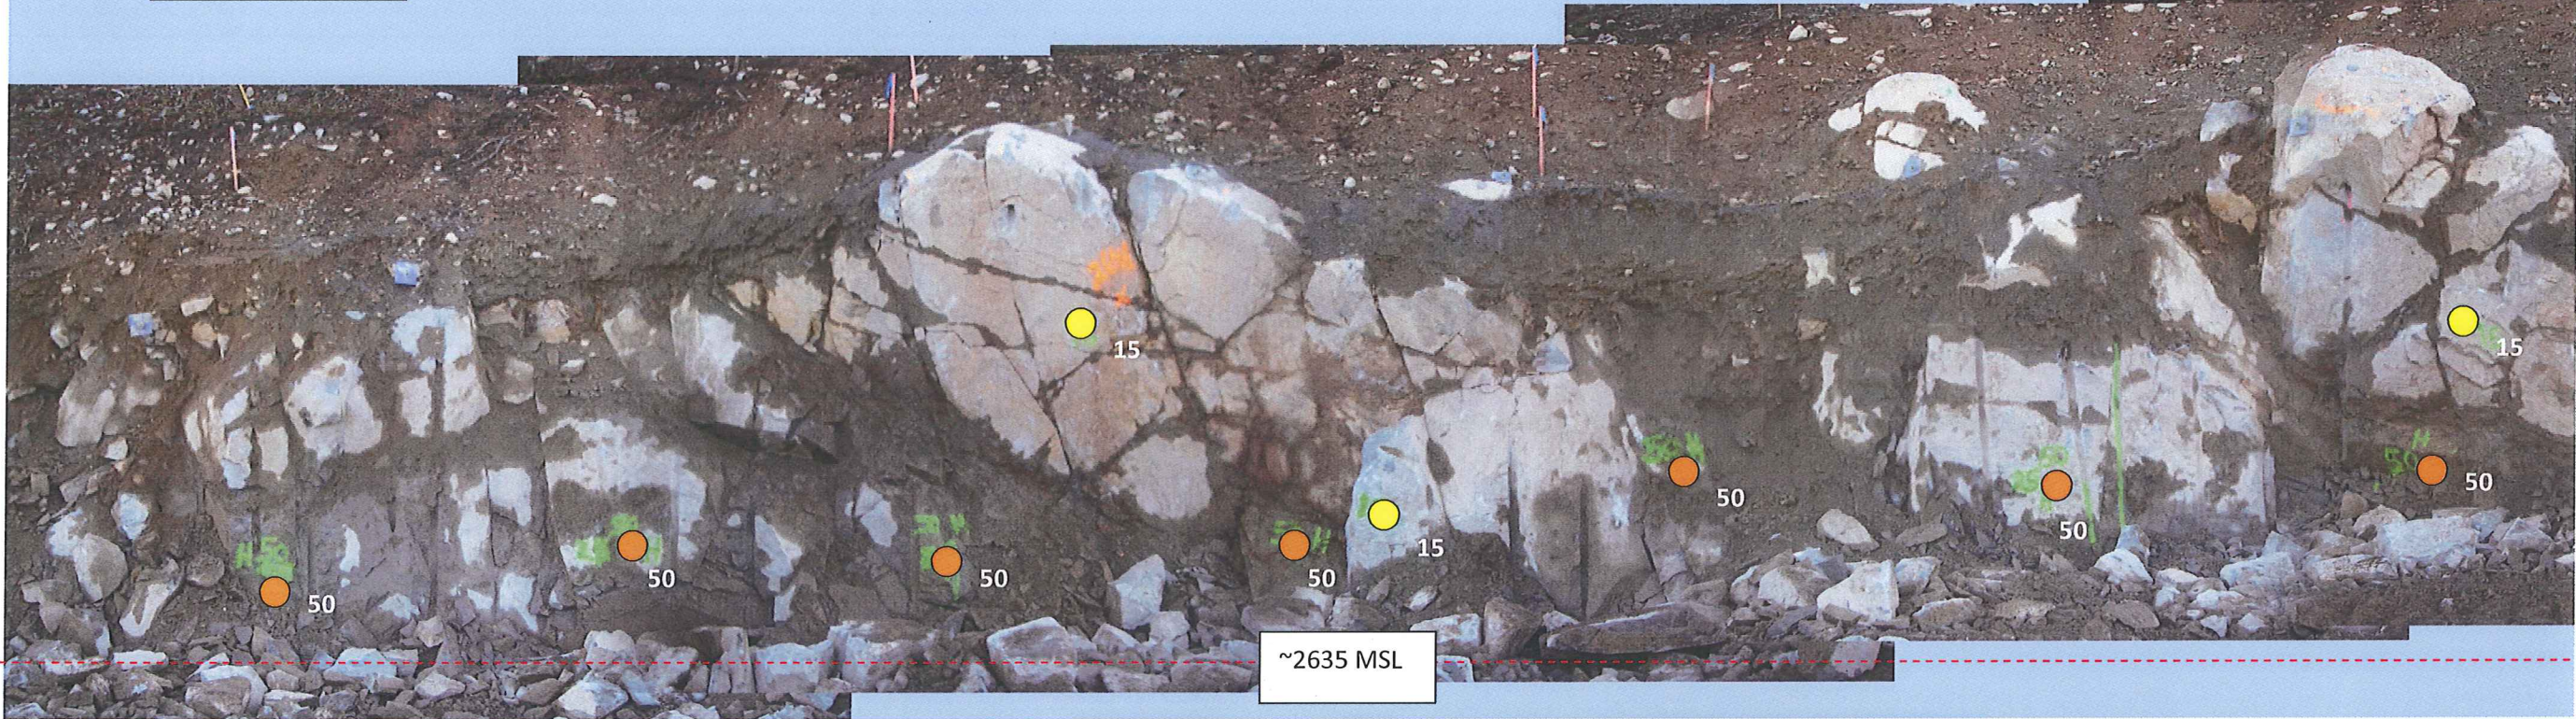
~ Station 1332+60

Brad, Rocki Bishop, and I walked up slope to perform the lift inspection from approximate station 1332+60 to 1334+25 to approximate elevation 2635 MSL as requested by the contractor the previous afternoon. We located 14 Type H Rock Dowels and 8 Type L Spot Dowels (Figure 1). Norm Norrish arrived during our lift inspection and assisted us with the locations of the rock dowels.
